# Racking Inspection

| SITE NAME<br>Manchester facility | DATE OF INSPECTION<br>16/02/2024 | INSPECTOR<br>Mike Jackson |

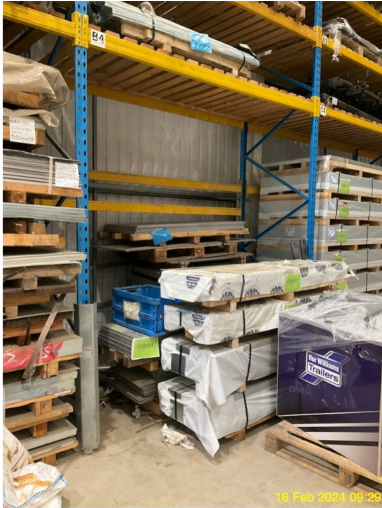
| Ref | Location | Product | Fault Type | Recommendations | Risk Factor |
|---|---|---|---|---|---|
| 48 | RDC | Sperrin | Damaged front beam L2 | Replace | Red |
